January 14, 2016

**Re: St. John's Lane Elementary School
Oversight during Mold Remediation and Investigation
HCPSS Contract Number: 087.12.B3 (IH Monitoring Services)
Tidewater Job Number: 1061-031**

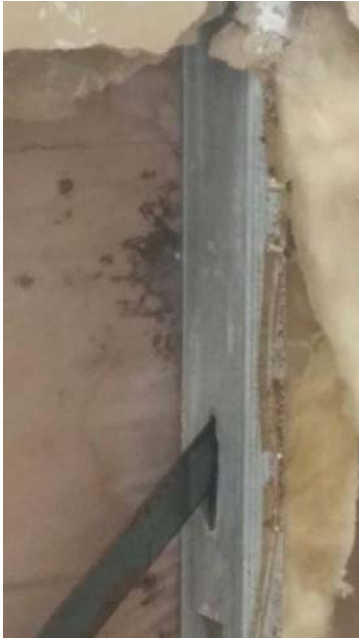
- Room 79: The interior drywall layer of the South wall in Room 79 was entirely demolished by ASI, within a full containment, and all moisture-impacted materials were removed. During this procedure, Tidewater observed mold growth on water-damaged fiberglass insulation within the wall cavity, and scattered areas of microbial growth and water staining on both interior and exterior layers of the drywall system (south wall). The contractor ASI cleaned the wall cavity with a vacuum equipped with High Efficiency Particulate Air (HEPA) filters to remove any residual accumulations of dust and debris. And then a Shockwave disinfectant sanitizer was applied on all surfaces and wood components.

Photo 1: St. John's Lane Room 79 – Mold and Water Staining

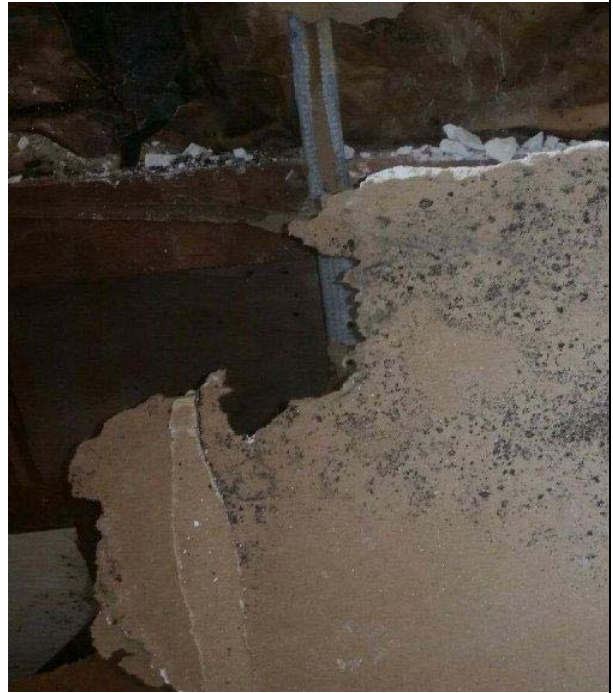
Photo 2: St. John's Lane Room 79 – Mold on the Drywall

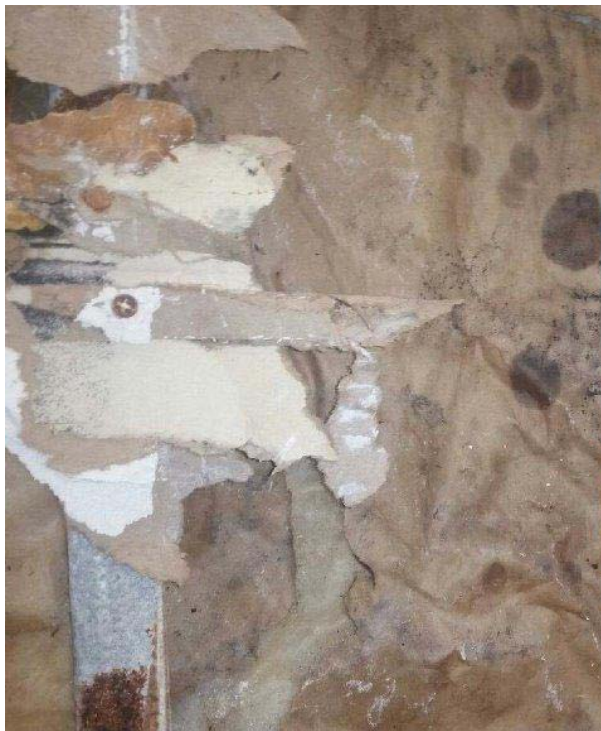
Photo 3: St. John's Lane Room 79 – Mold on the Batting Insulation and Drywall

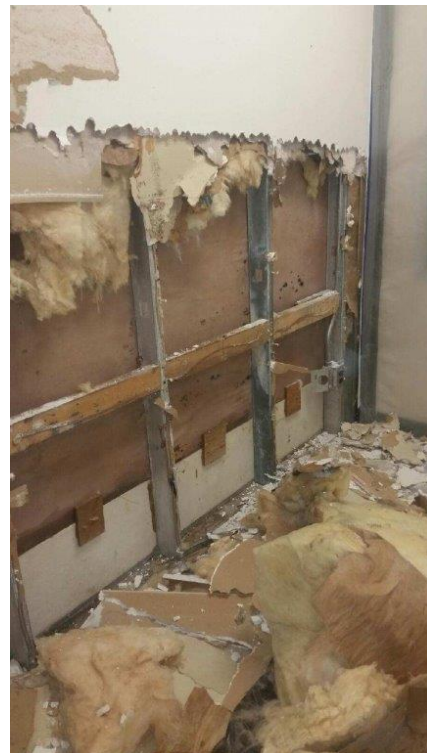
Photo 4: : St. John's Lane Room 79 – Mold on the Batting Insulation and Drywall

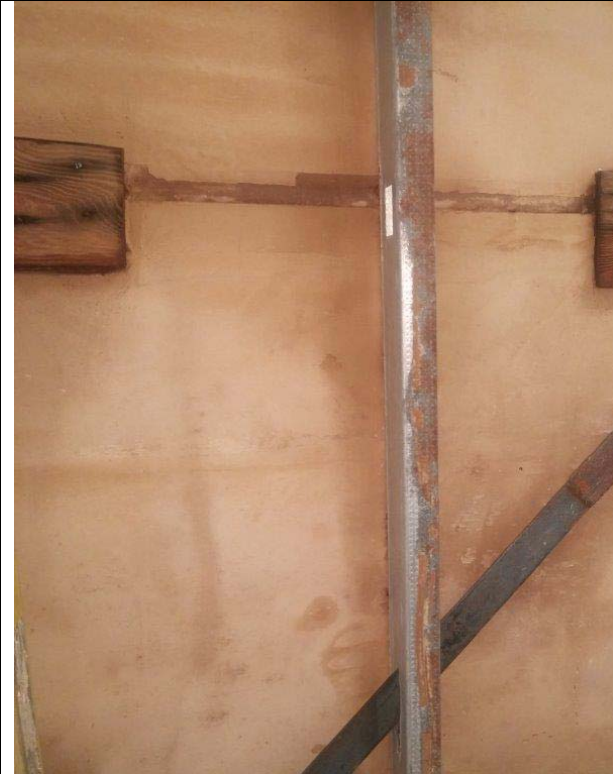
Photo 5: St. John's Lane Room 79 – After Remediation

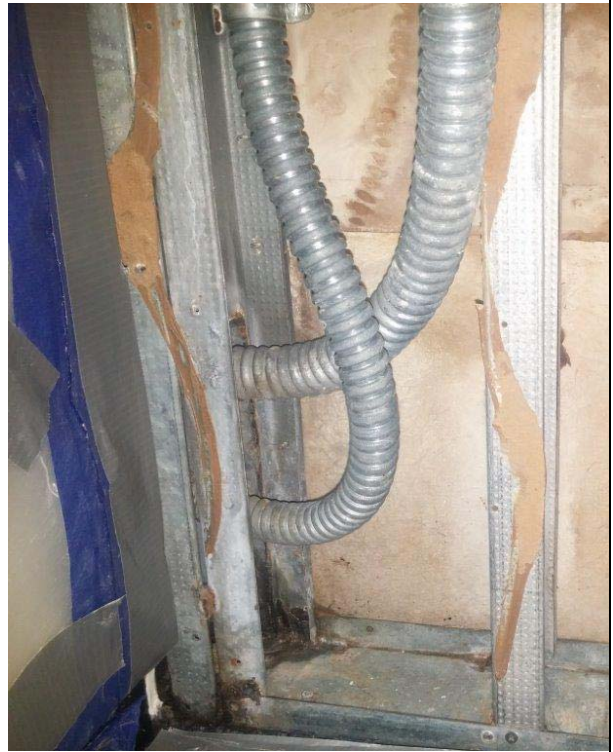
Photo 6: St. John's Lane Room 79 – After Remediation

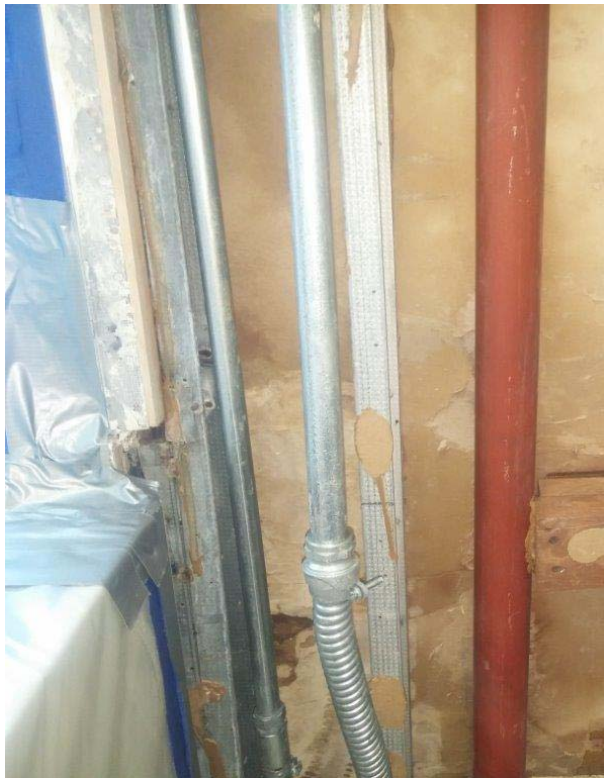
Photo 7: St. John's Lane Room 79 – After Remediation

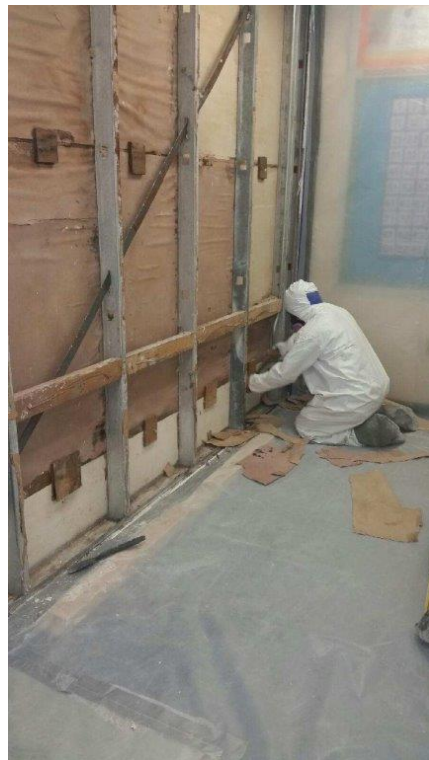
Photo 8: St. John's Lane Room 79 – After Remediation

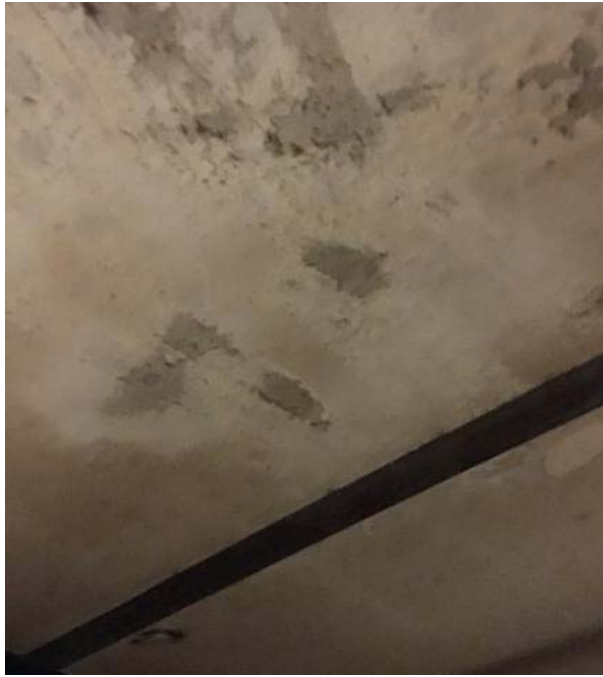
- Library Room 102: Critical barriers were erected at the entrance door of the Library Room where water staining and microbial growth was identified on the drywall roof deck above the doorway. The fiberglass batt insulation in the impacted area was removed for proper disposal. ASI HEPA vacuumed and cleaned the surfaces on the roof deck, and applied the Shockwave disinfectant sanitizer on all the surfaces.

Photo 9: St. John's Lane Library Room 102 Above Doorway – Mold on the Roof Deck Drywall

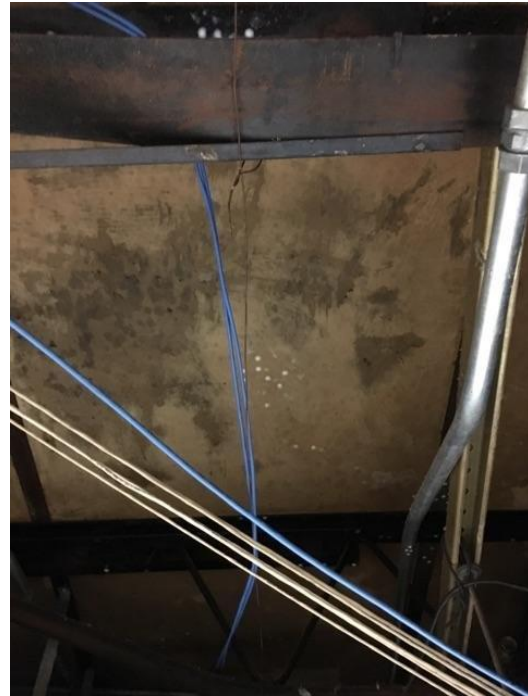
Photo 10: St. John's Lane Library Room 102 Above Doorway – After Remediation

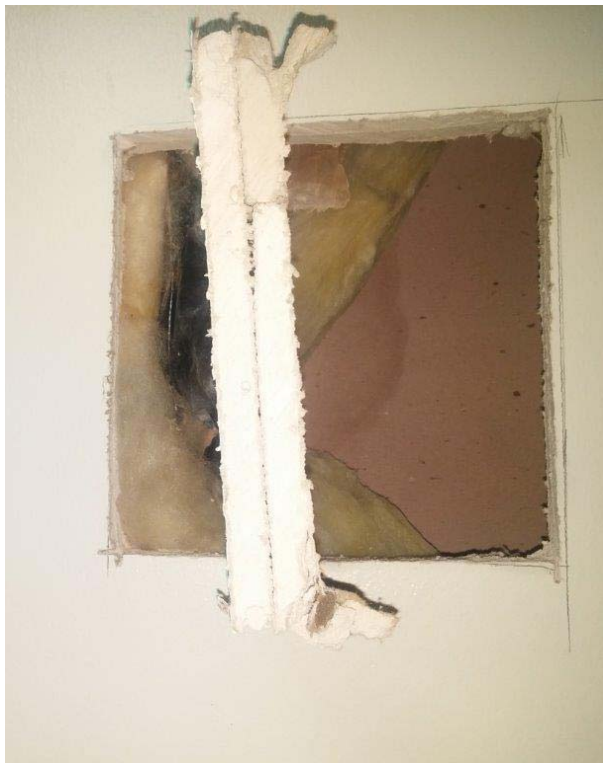
- Rooms 81, 82, 83, 84 and 85: ASI made 12" x 12" test cuts in the drywall to facilitate observations of hidden mold and water intrusion inside the wall cavity. Test cuts were made in Room 81 south wall, Room 82 South wall, Room 83 East wall, Room 84 North wall, and Room 85 North wall. In all instances, Tidewater observed wet fiberglass insulation and patches of mold growth and water staining on the drywall. ASI cleaned, HEPA vacuumed, and applied the Shockwave disinfectant sanitizer to all the surfaces within these openings.

Photo 11: St. John's Lane Room 82 Test Cut on South wall – Presence of Mold and Water-staining

- Prior to implementing remediation action, the underlying cause(s) of moisture/water intrusion shall be rectified to mitigate reoccurrences of intrusion and/or future microbial growth.
- Rooms 81, 82, 83, 84 and 85 should be further addressed to demarcate the area and extent of microbial growth and water-impacted building materials.
- Additional moisture/water-impacted materials and materials exhibiting suspect mold growth should be remediated by a qualified contractor experienced in microbial and/or water infiltration remediation procedures.

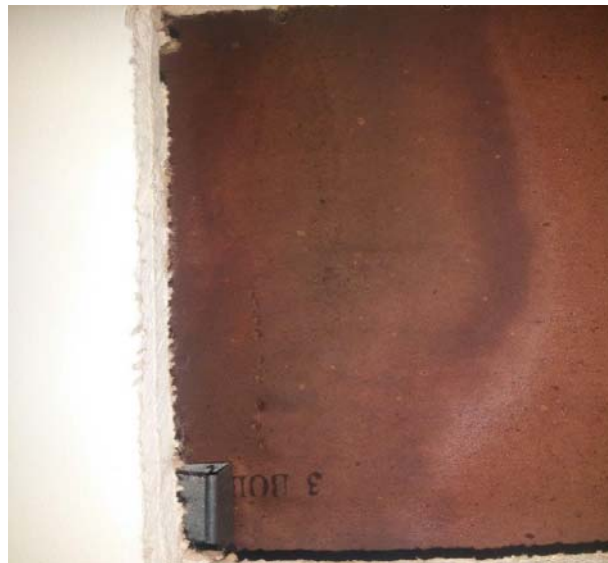
Photo 12: : St. John's Lane Room 82 Test Cut– After Cleanup and Encapsulation with Shockwave Sanitizer

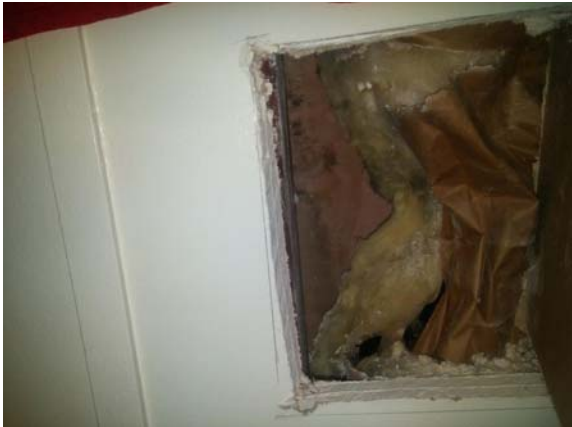
Photo 13: St. John's Lane ES Room 83 Test Cut – Presence of Mold and Water-Impacted Materials

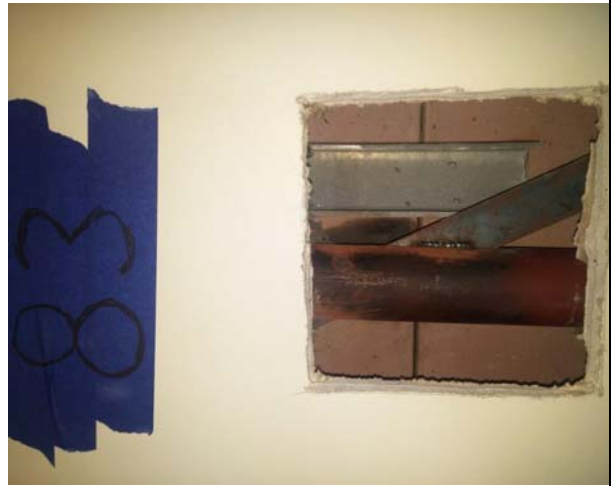
Photo 14: St. John's Lane ES Room 83 – After Cleanup and Encapsulation with Shockwave Sanitizer

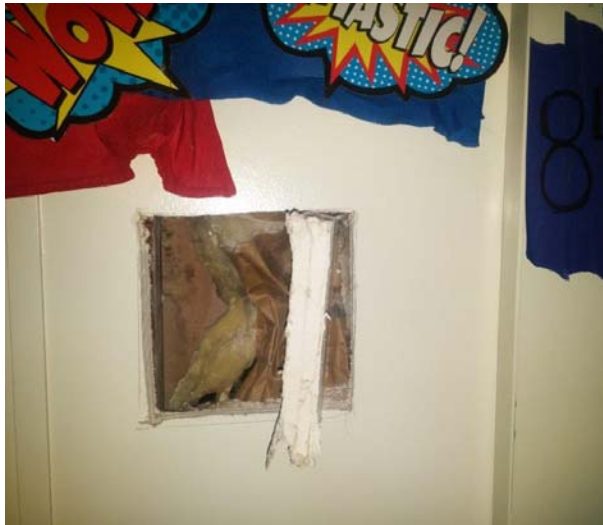
Photo 15: St. John's Lane Room 84 Test Cut – Presence of Mold and Water-staining

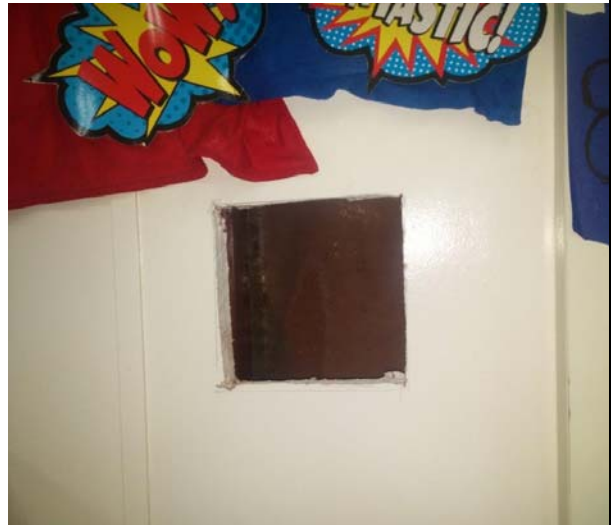
Photo 16: : St. John's Lane Room 84 Test Cut– After Cleanup and Encapsulation with Shockwave Sanitizer

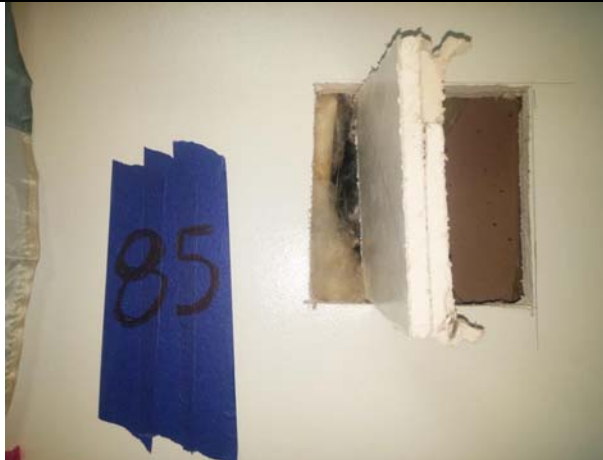
Photo 17: St. John's Lane Room 85 Test Cut – Presence of Mold and Water-staining

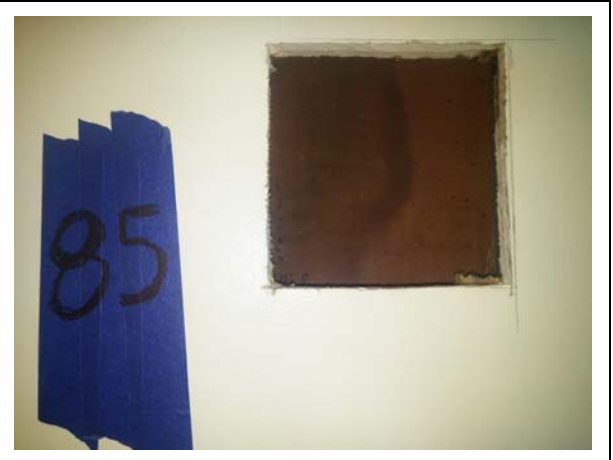
Photo 18: : St. John's Lane Room 85 Test Cut– After Cleanup and Encapsulation with Shockwave Sanitizer
