January 14, 2016

**Re: St. John's Lane Elementary School
Oversight during Mold Remediation and Investigation
HCPSS Contract Number: 087.12.B3 (IH Monitoring Services)
Tidewater Job Number: 1061-031**

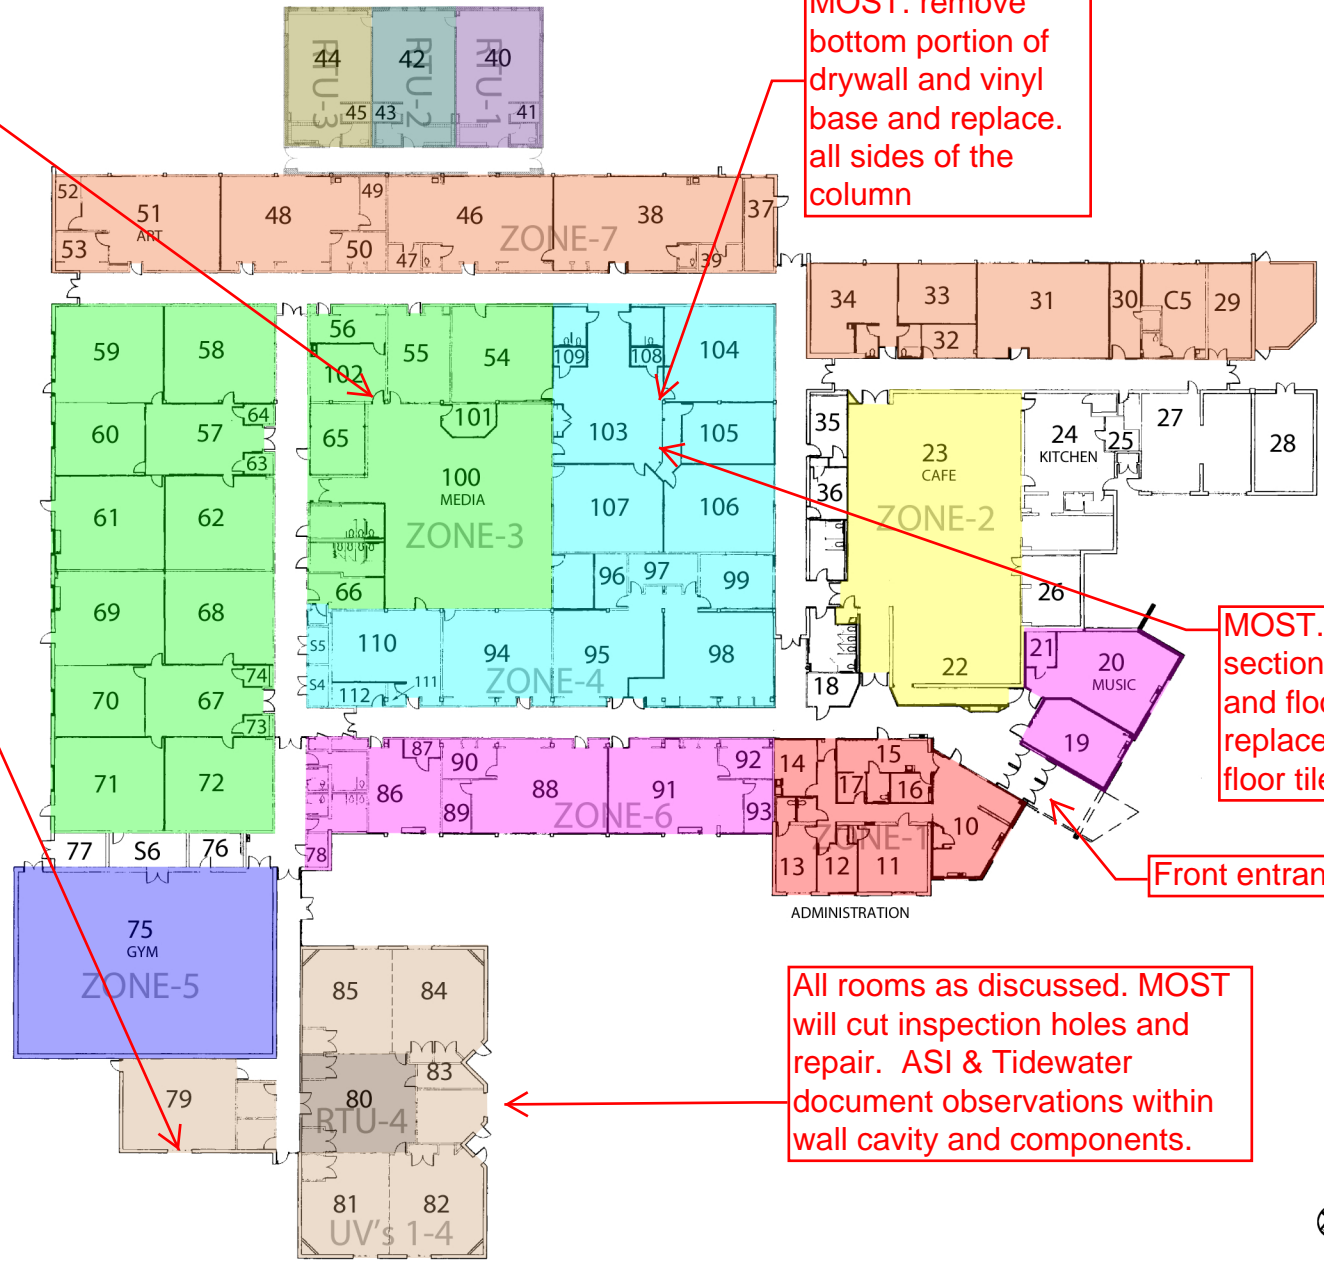
ASI. above doorway remove additional fiberglass batt insulation to survey extent of minor mold spotting as observed in exposed area of gypsum roof deck. disinfect and seal.

MOST. remove bottom portion of drywall and vinyl base and replace. all sides of the column

ASI. Wall removal. MOST. wall replacement.

MOST. Remove section of carpet and floor tile and replace with new floor tile

All rooms as discussed. MOST will cut inspection holes and repair. ASI & Tidewater document observations within wall cavity and components.
